Tearing at the Margin

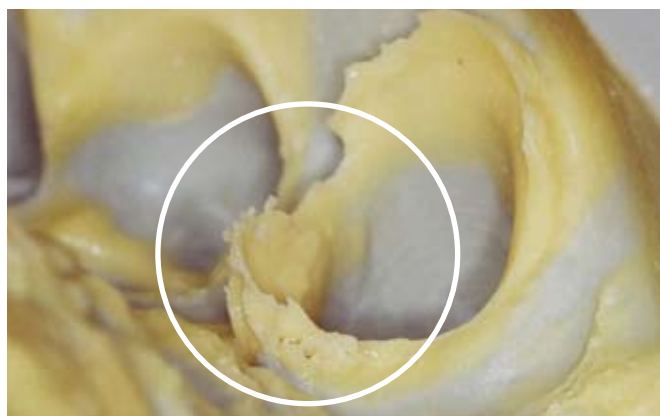
Visual Appearance: Rip, or visible tearing on the margin of the preparation.

Result: Short crown margins and/or open margins.

CAUSE	SOLUTION
Expired impression material.	Check expiration date of impression material.
Inadequate mix.	Bleed before applying mix tip to ensure even dispensing. Use proper mix tip. Ensure mixing instructions are followed and materials have a streak-free appearance.
Insufficient retraction.	Displace tissue to allow the impression material to access prepared area. Consider two-cord retraction. Leave pilot cord in the sulcus when taking the impression. Use impression material with sufficient tear resistance.

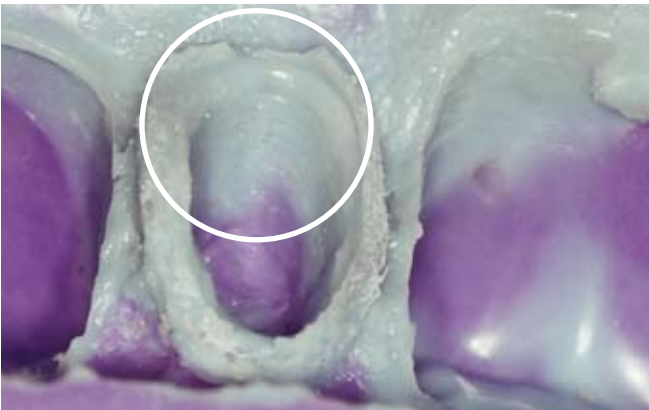
Tearing at the Margin

Poor Retraction — Insufficient Tear Resistance

Substances with $\text{pH} < 4$ inhibit setting reaction, most commonly by contact with acidic retraction materials and hemostatic agents containing epinephrine or ferric sulfates.

Sulfur inhibition due to contact of latex gloves with tissue/tooth/retraction material or impression material.

Residues from custom temporary or provisional cements (acrylics) present.

Use retraction materials with a $\text{pH} \geq 4$.
Select retraction materials and hemostatic agents that do not contain these chemicals.

Rinse, remove, and dilute hemostatic solution from the preparation with water spray and suction. Dry before taking the impression.

Wear gloves proven not to contain traces of sulfur.

If contamination is suspected, scrub affected area with diluted hydrogen peroxide.

Do not use impressions already used to fabricate the temporary restoration.

Fabricate the temporary crown or bridge after final impression has been made.

Remove air-inhibited layer on the exposed surface with an alcohol wipe before making final impression.
