Tray-Tooth Contact

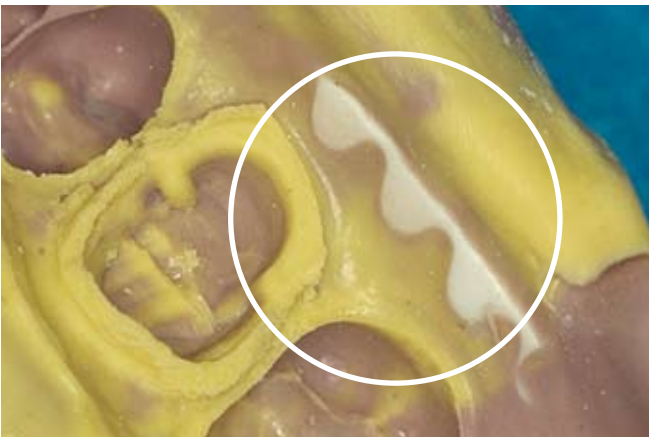
Contact with Impression Tray

Visual Appearance: Show-through of tray. Impression tray exposed.

Result: Restoration may have slight distortion at marginal area, or rocks.

Prepared teeth contact the sides or bottom of impression tray.

Use proper size tray.

Test various tray sizes to ensure proper size.

Carve out tray material properly before applying wash.

Fill tray adequately.
